DEPARTMENT OF TRANSPORTATION

Quality Assurance and Source Inspection

Contract #: 04-0120F4Cty: SF/ALA Rte: 80 PM: 13.2/13.9File #: 1.28**WELDING INSPECTION REPORT****Resident Engineer:** Casey, William**Address:** 333 Burma Road**City:** Oakland, CA 94607**Report No:** WIR-028400**Date Inspected:** 15-Sep-2012**Project Name:** SAS Superstructure**OSM Arrival Time:** 700**Prime Contractor:** American Bridge/Fluor Enterprises, a JV**OSM Departure Time:** 1530**Contractor:** American Bridge/Fluor Enterprises, a JV**Location:** jobsite**CWI Name:** Scott Kortum**CWI Present:** Yes No**Inspected CWI report:** Yes No N/A**Rod Oven in Use:** Yes No N/A**Electrode to specification:** Yes No N/A**Weld Procedures Followed:** Yes No N/A**Qualified Welders:** Yes No N/A**Verified Joint Fit-up:** Yes No N/A**Approved Drawings:** Yes No N/A**Approved WPS:** Yes No N/A**Delayed / Cancelled:** Yes No N/A**Bridge No:** 34-0006**Component:** OBG**Summary of Items Observed:**

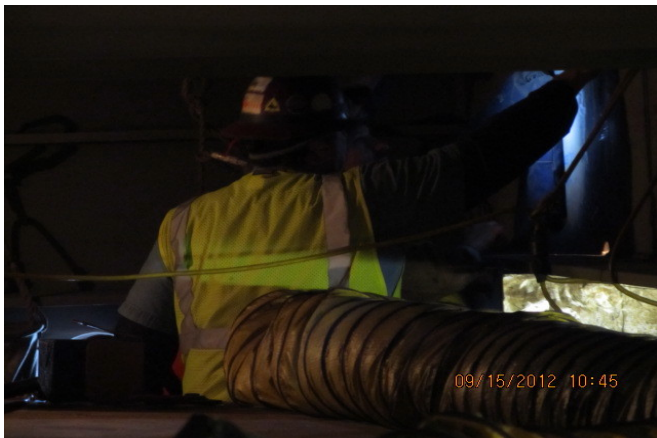
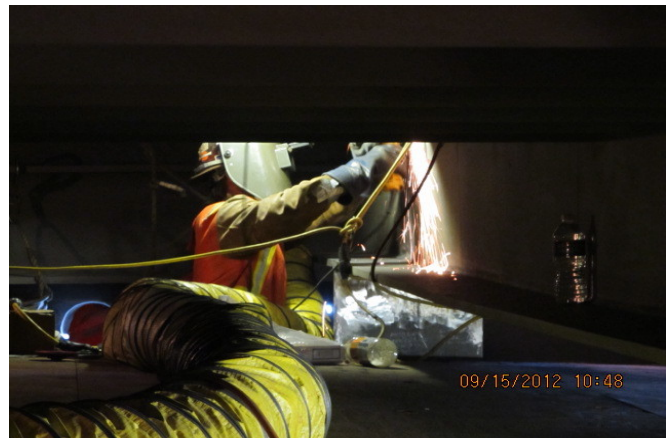
This QA inspector observed weld repair being performed by ABF welding personnel Richard Garcia on Deck Splice 13W-W2.3, at the following location(s):

Y: 2530mm, L: 1500mm, W: 60mm, D: 12mm

This QA Inspector observed Mr. Garcia preheating to a QC recorded, QA verified temperature of 250F prior to using the Carbon Arc Gouging process to remove defects at the above-mentioned locations on the Splice. The locations and depth of the defects had been marked on the steel by the Ultrasonic Technician at the conclusion of his testing. At the end of gouging operations Mr. Garcia ground the excavations to a bright clean metal condition in preparation of Visual, Magnetic Particle Testing, and welding.

Prior to welding Quality Control Technician Scott Kortum performed Visual and Magnetic Particle Testing on the above excavations. This Quality Assurance Inspector verified the results of the test by doing duplicate testing to the excavations. No indications were noted.

The welder spent a fraction of the shift depositing the root passes and fill passes with approximately 100% being completed at the end of the shift. QC inspector Scott Kortum was noted to be present in order to monitor the progress and ensure the welding was within the established Welding Procedure Specification (WPS) noted as ABF-WPS-D15-1004R (Rev 0) and supporting Procedure Qualification Records (PQR). Prior to initiating the welding at this location the QC inspector observed the preheat temperature and post heat temperature using a Raytek non-contact Thermometer, was sufficient and compliant to the above-mentioned WPS. Using a Tempil Stick, (temperature indicating crayon) the preheat, and post heat temperature was then verified by this QA inspector to be greater than 350F and 450F respectively. Using a Fluke brand Tong style meter, the parameters were verified to be 133 amps
